Message/Alarm “Clean C-HEAD” appears

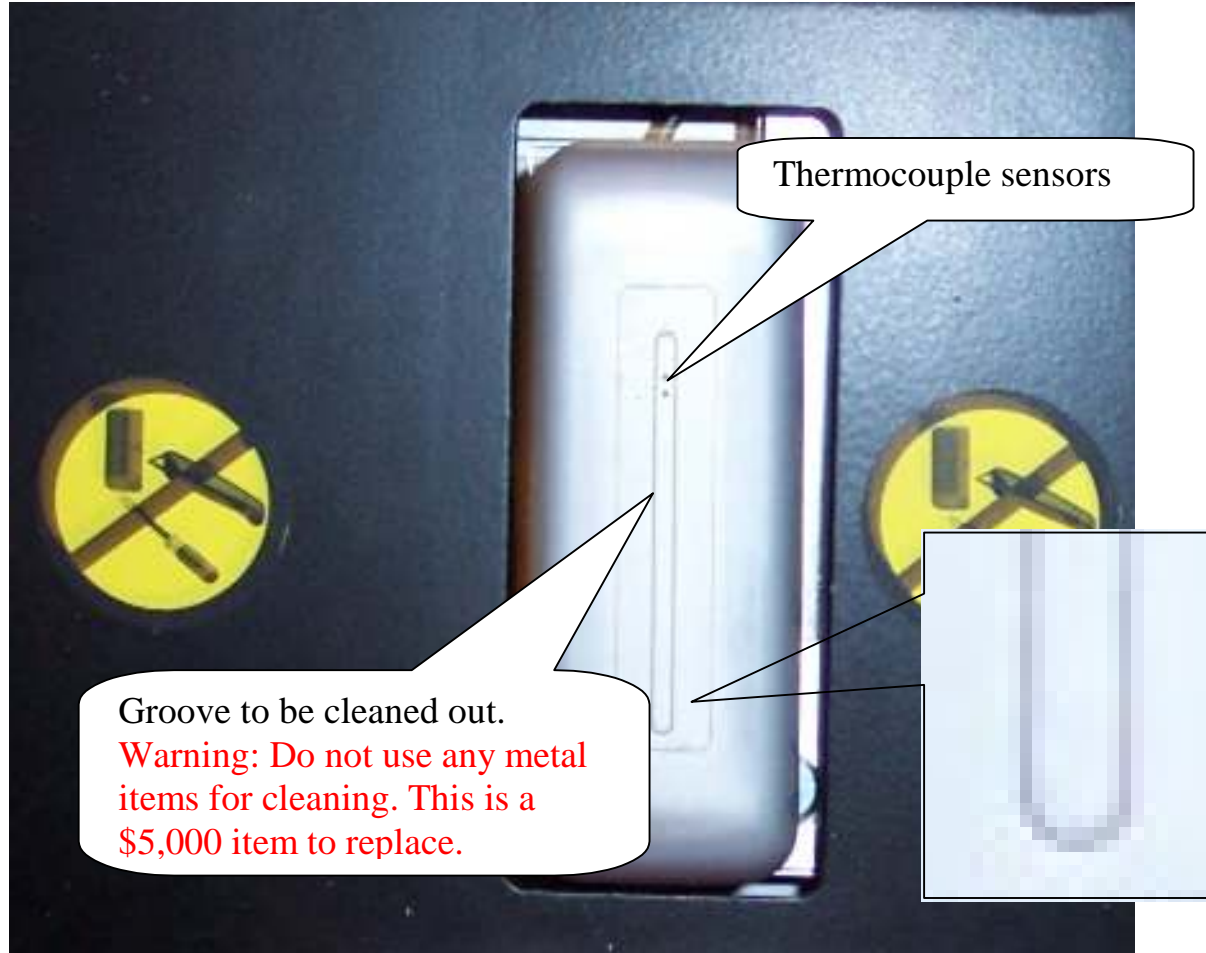
A build up of resin and dirt will cause a bridging across the gap on the capacitive sensor reducing the measurement reading. It is recommended to clean the sensor on a 4 week cycle depending on polymers used and content of reclaim. It only takes five minutes and can be done with the line running if desired.

If the profile measurement is running, stop the function by either double touching the PROFILE button on the machine control screen or turning off the power on the control box PC9 that controls the profile scanner. Stop the radial adjustment arm where it is best reachable for cleaning.

- With a clean cotton rag and an alcohol based cleaning solution wipe the surface of the capacitive sensor until no visible dirt or polymer is showing.
- With a non-metal tool, (i.e. toothpick, sharpened piece of wood, toothbrush, pointed plastic item) clean out the groove that goes around the center of the sensor. This area will collect polymer and dirt and over time will short out the two capacitive plates.
- Restart the measurement sensor, remember to turn on the scanner if the switch was turned off on the PC9 box.
